MULLER MIXER FIRE
"LESSONS LEARNED"

MORTON THIOKOL, INC.

Longhorn Division

↙
The purpose of this paper is to share some of the actions taken by Morton Thiokol, Inc. to enhance safety in pyrotechnic muller mixing operations at Longhorn Army Ammunition Plant. These initiatives resulted from the investigation of a muller mixer fire which occurred on October 30, 1985. It is the safety management philosophy of Morton Thiokol Ordnance Operations that all explosive accidents and significant near miss incidents be thoroughly investigated, by the Engineering and Safety Committee, utilizing a safety systems approach. This committee, which is chaired by the Director of Engineering, B. V. Diercks at the Longhorn Division, was charged with identifying the causative deficiencies and ancillary procedural, equipment design and human engineering changes required to enhance the overall system. To assist Mr. Diercks in this investigation, the following personnel were key contributors in the safety initiatives developed from the analysis of this incident:

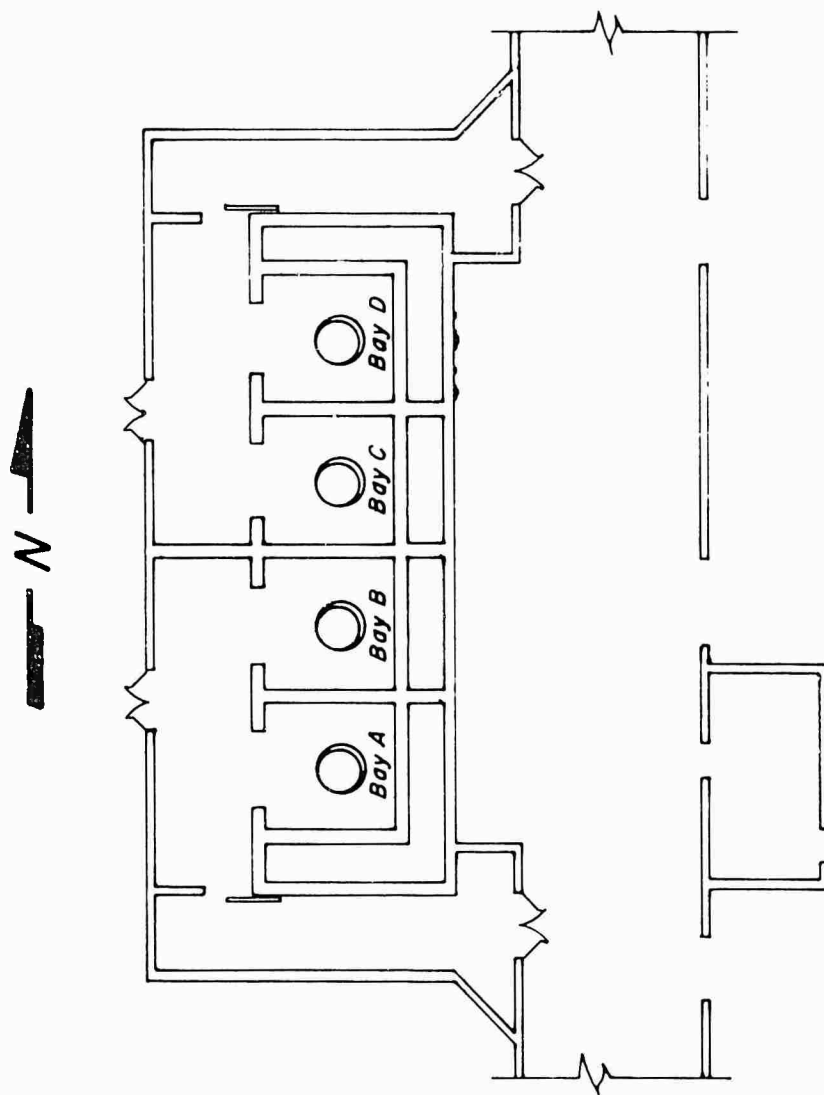
Figure 1

Longhorn AAP has used this blade to bowl contact mulling procedure since the mid-60's. The mixer wheels/plows revolve at approximately 18 RPM and are driven by an 1800 RPM 3 H.P. motor through a double belt sheave and gear box. The bowl diameter is approximately 39 inches and 12 inches deep with the mulling wheels/plows geared to move in a counterclockwise rotation. All bays are equipped with closed circuit TV monitors, Backarack explosive vapor alarms, Detronics UV rapid acting deluge and fusible link wet pipe fire protection systems with electrically interlocked emergency exit doors, fire door and vapor alarms to remote controls. Also provided is 100 percent make up air with temperature and humidity control, vapor/dust removal systems connected to an external wet type Rotoclone dust collector that is electrically interlocked to the control panel. Walls between bays and control room are substantial dividing walls of 12 inch thick reinforced concrete with three feet of sand fill between bay and control station walls. (Figure 1 illustrates B11 configuration)

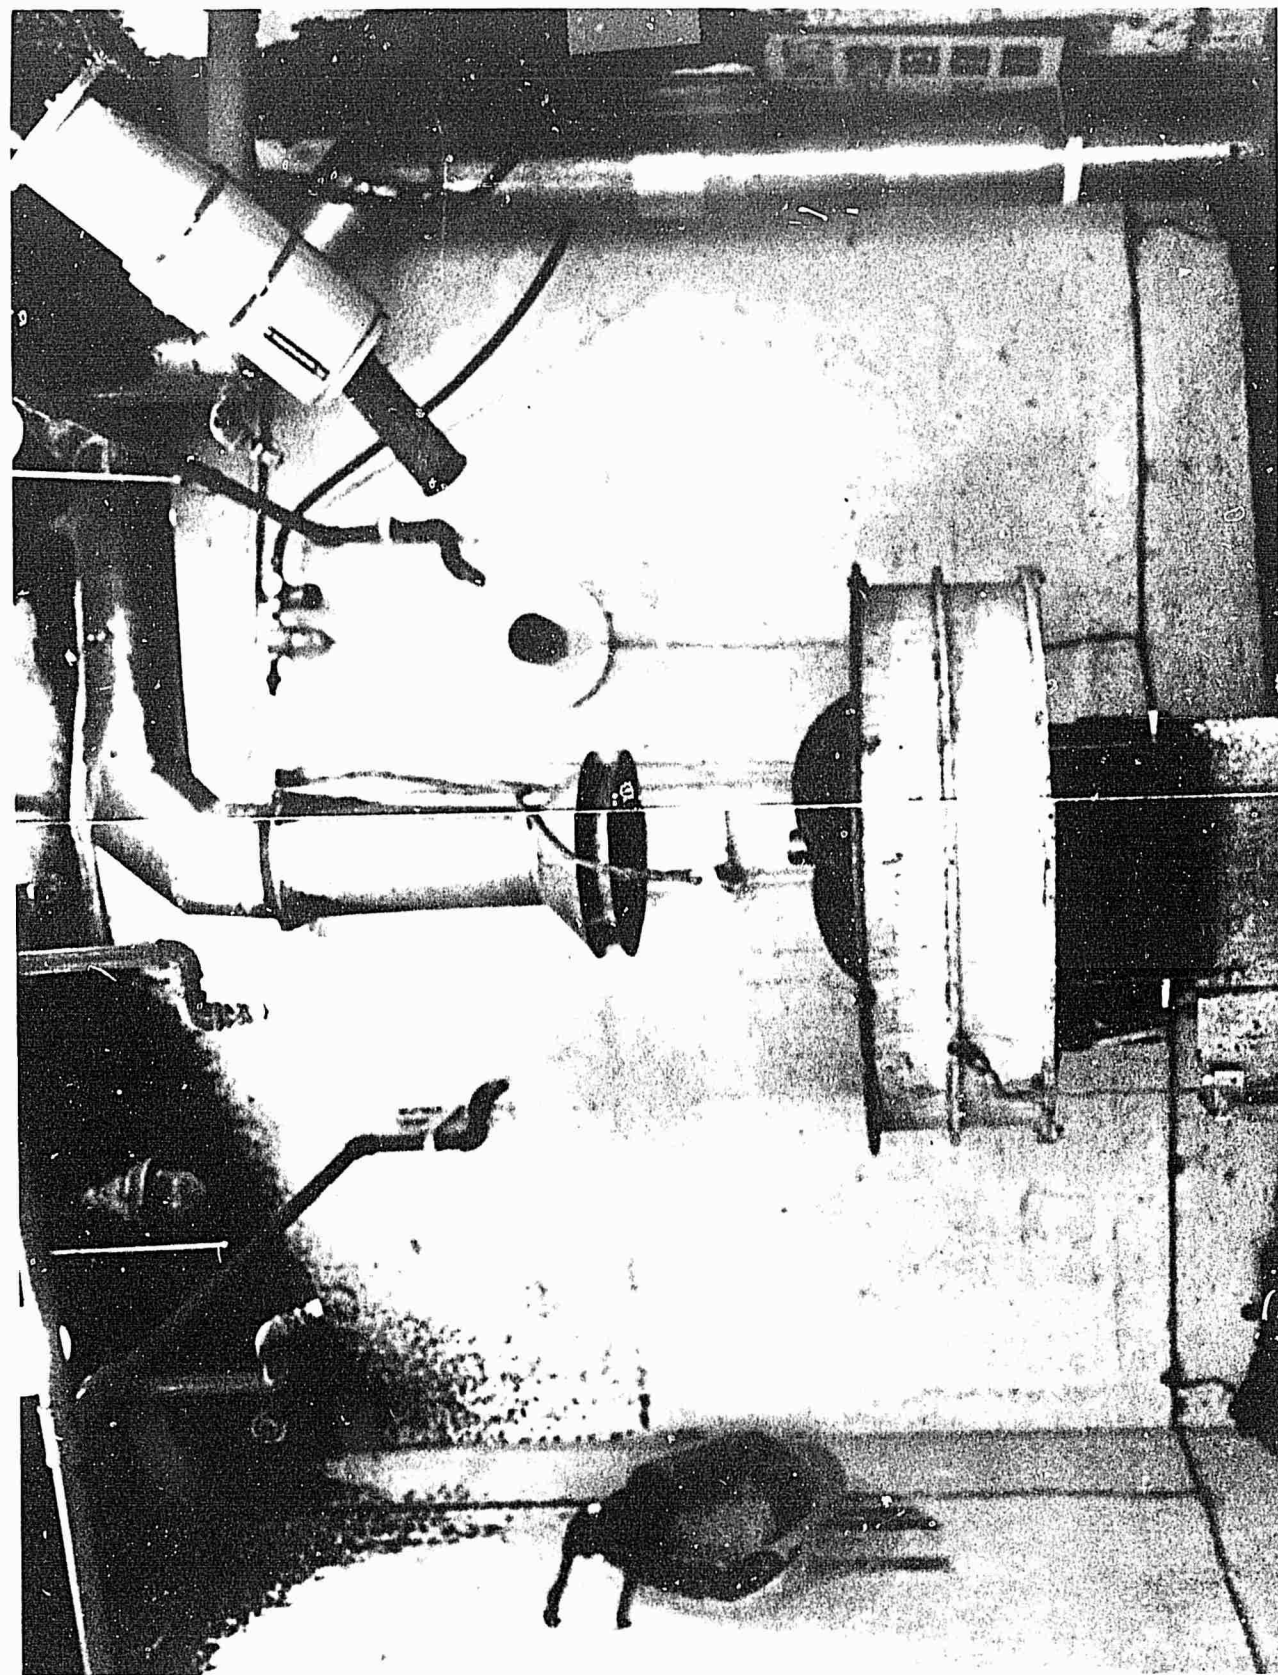
Figure 2

forced into the back corridor and out the emergency exit nearest Bay D. The fire ball also vented over the top edge of the sliding corridor fire door igniting contaminated surface along the fire door track and ceiling. In interviewing the operator who was supposed to have been watching the TV monitors, there was no indication of a problem before she heard a boom and looked up and to see Bay D engulfed in flames on the TV monitor. (Figure 2 shows damage in Bay D)

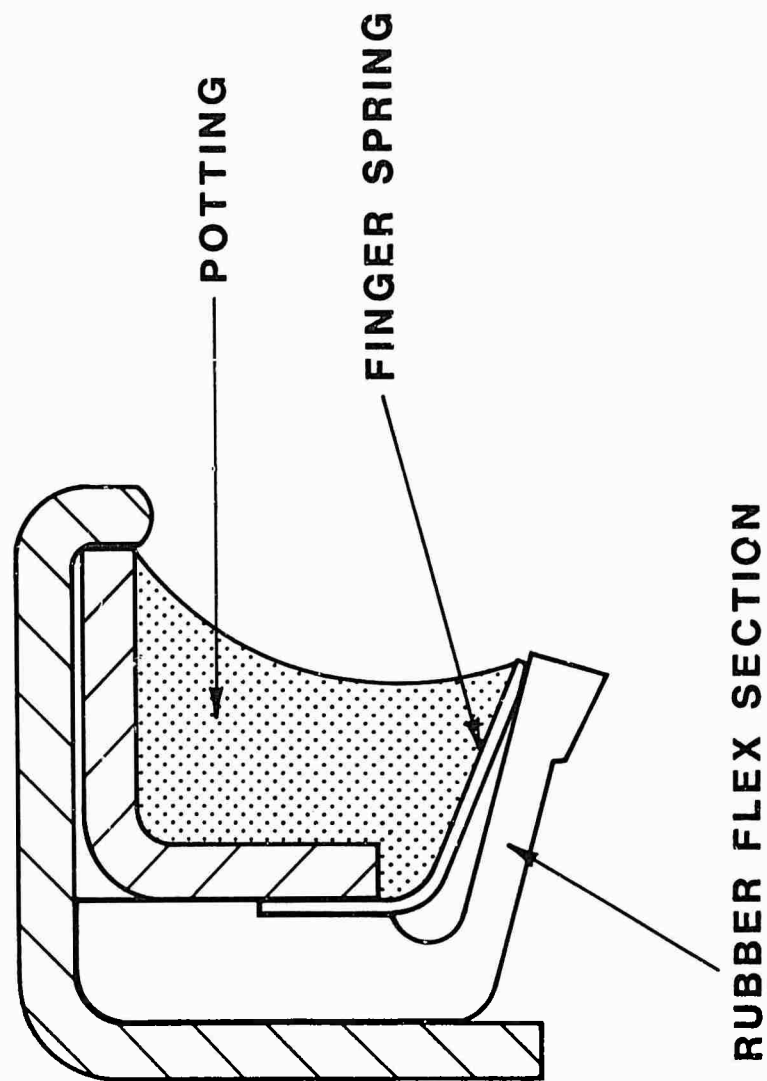
Figure 5

The most probable cause was identified during detailed disassembly of the muller wheels which found a damaged Garlock Klosure Lip Seal. Under microscopic examination it was apparent that the metal spring fingers in the lip seal had made metal to metal contact with the axle plus there was indication of fire in the area. Small amounts of explosive contamination were also found past the lip seals in bearings of both the muller wheel and center support post. To correct this deficiency the muller wheel assembly (Figures 3 and 4) has been redesigned with a redundant Ethylene Propylene "O" ring seal plus potting the void in lip seal with solvent resistant Epon 828 and Versamid 125 filler. The lip seal filler prevents explosive product entrapment and build up at the edge of the lip seal, protects finger springs, and aids in cleaning of center support post lip seal. The effectiveness of this lip seal configuration was tested in inert and live prove out mixes which established a twenty (20) shift replacement schedule of all lip seals and bearings. This preventive maintenance baseline may be extended as future experience warrants. Eight months of continuous operations has seen no migration of product past lip seals. (See Figure 5)

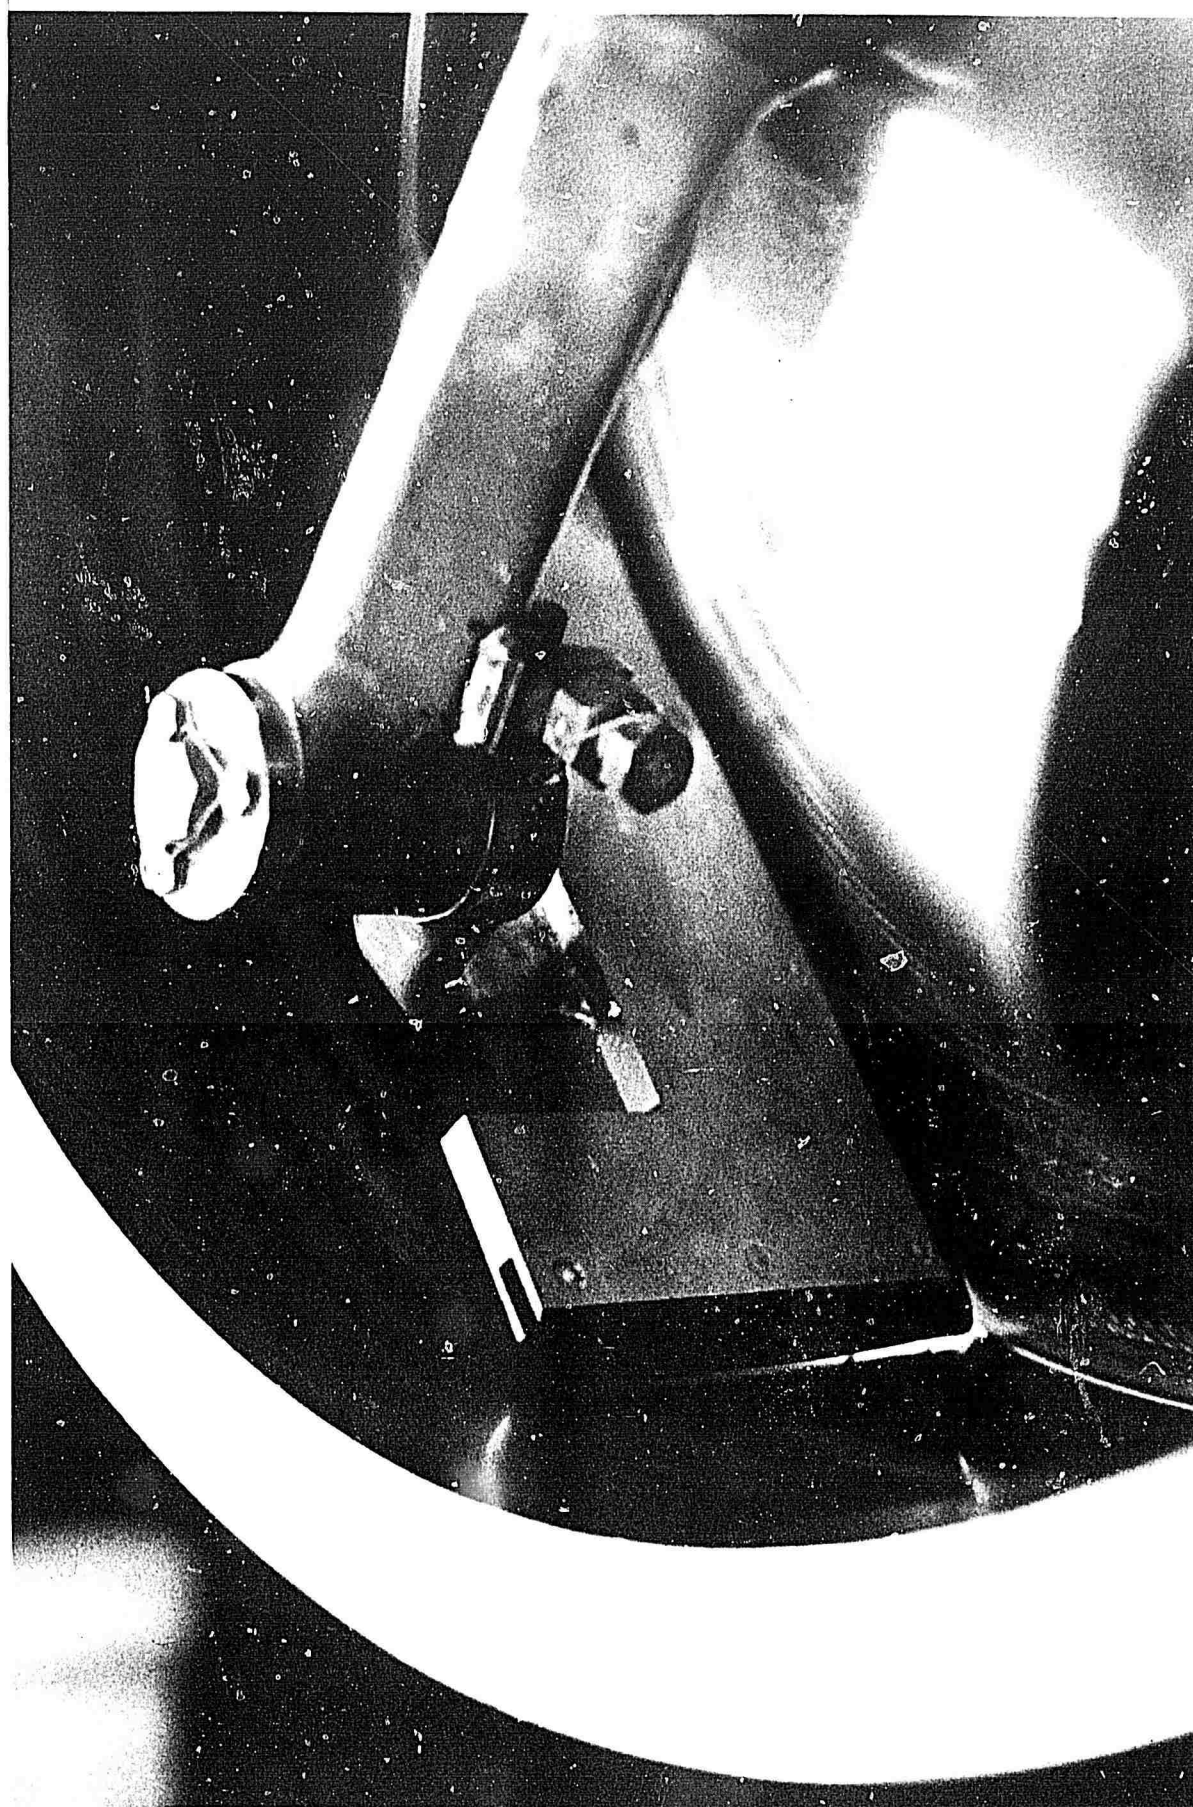
Figure 6

Longhorn Division has used nylon wiper/plow blades in "Zero" clearance with bowl surfaces for over ten (10) years without incident. The rough condition of bowl surface was due to years of continuous multi-product use without an adequate program to periodically reface bowl and wheel surfaces. The result was a badly worn bowl and muller wheel surface. In addition, it was also discovered that the Total Indicated Runout (TIR) of the bowl was excessive and that the bowl flexed when torque was applied from drive belts. To correct these deficiencies the bowl and wheels were refaced to remove all scratches, scores and gouges, the high points of the mixer wall and bottom were identified and marked on the bowl plus a drive belt tension stabilizer support was added to drive shaft. The muller wheels were also slightly crowned to push possible foreign material out from under wheel. The nylon blades were replaced with ultra high molecular weight conductive polyethylene blades which are installed with a minimum .030 clearance. This blade to bowl clearance is verified daily by production foreman. The last two initiatives were felt necessary to increase our safety margin by eliminating the possibility of static charge generation buildup on nylon blades. The .030 standoff also reduces the potential for blade/bowl friction points. In addition, a nylon bolt was added between rocker arm and crosshead to prevent metal to metal contact and pinching of material. (See Figure 6)
